POST-TEST ANALYSIS OF BRUNSWICK
MOD SHELTER TESTED IN DICE THROW

BY JOHN M. CALLIGEROS

JULY 1979

THE MITRE CORPORATION

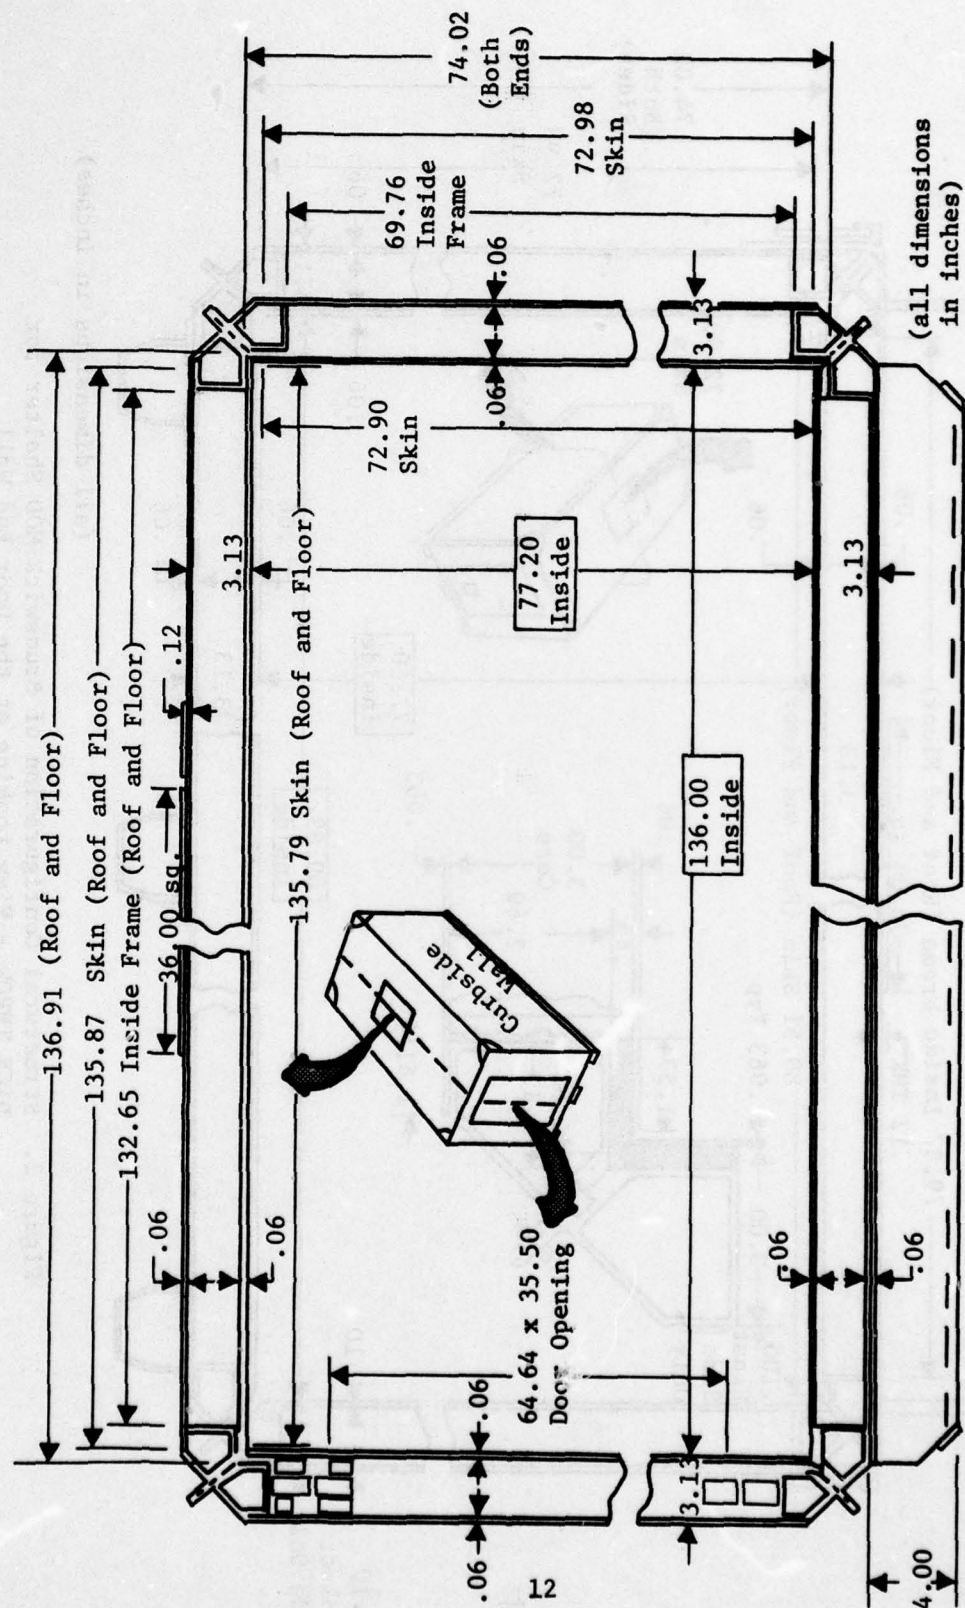
Figure 3. Structural Configuration of Brunswick MOD Shelter for DICE THROW - View Looking at Curbside Wall

Structural details of the MOD shelter are shown in Figures 2 and 3. Each roadside wall core facing (inside and outside) consisted of three aluminum sheets 0.10 inch thick connected by two vertical splice strips located approximately 48 inches from the shelter ends (Figure 4). Splicing was necessitated because of the unavailability of large-sized sheets of 0.10 inch thickness at the time. Since the roadside wall would receive the impact of the shock wave, vertical extrusions were riveted at each splice location to provide additional strength. The panel facings for the remaining shelter walls were made from continuous sheets 0.063 inch thick and did not include stiffening extrusions. It is believed that 5052-H34 sheet aluminum was used throughout for the facing material, and 6061-T6 aluminum for the edge and vertical extrusions.

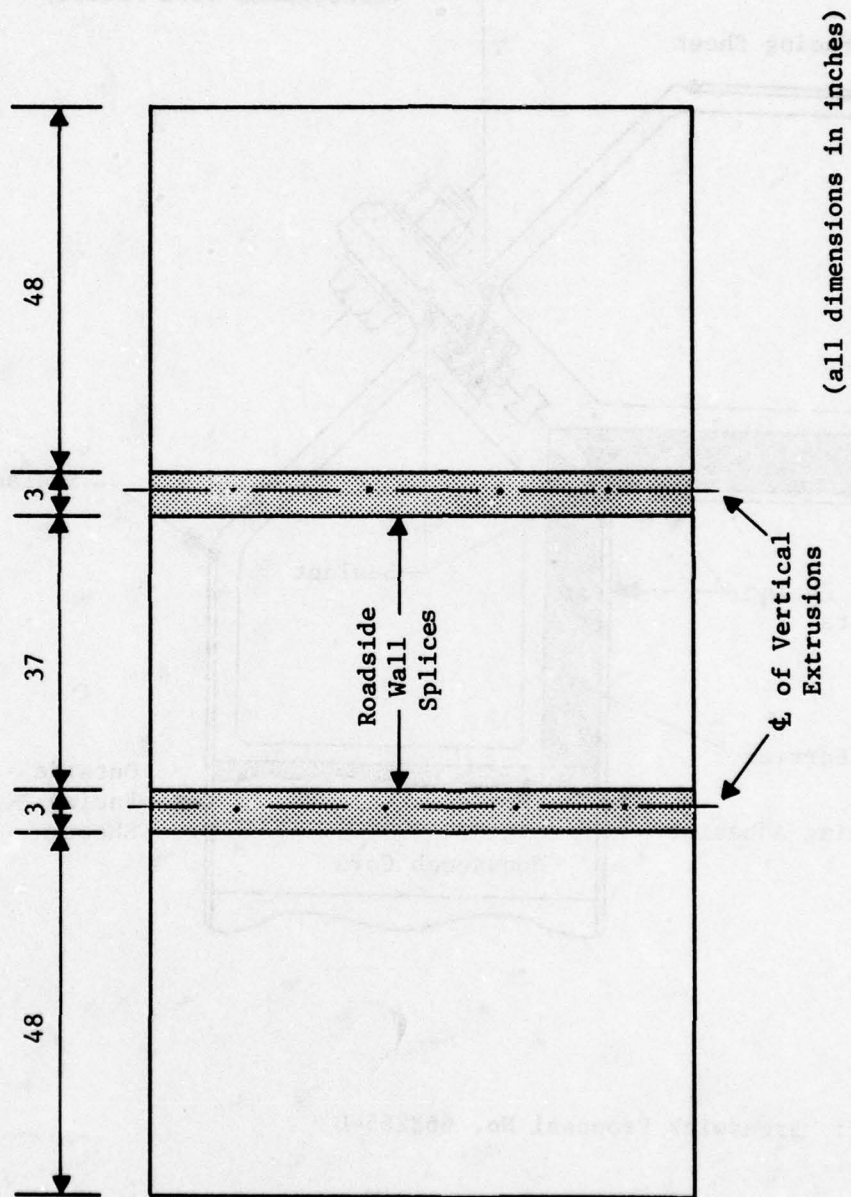
Figure 4. Splice and Vertical Extrusion Locations
For Roadside Wall

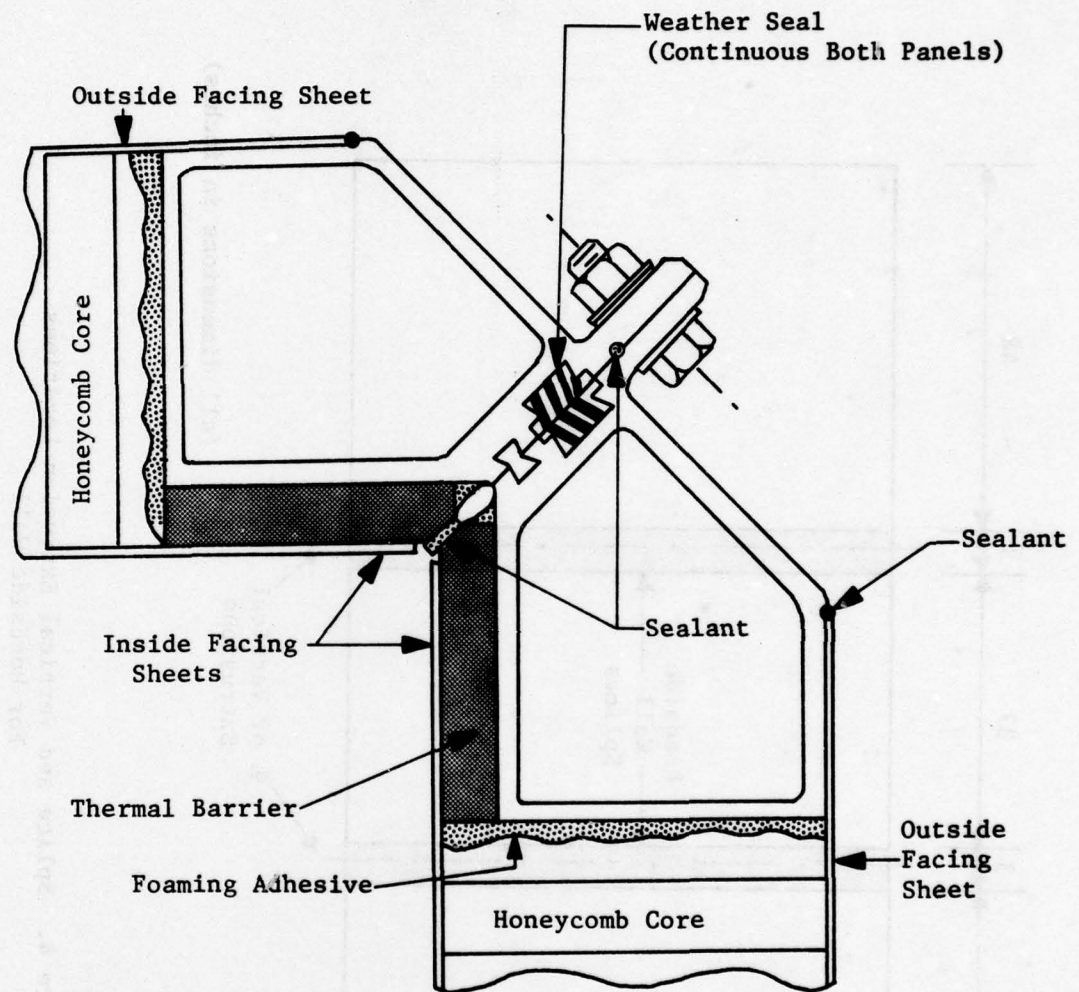
Figure 5. Edge Extrusion and Panel Joining Detail

Cross-sectional views of the edge extrusions, which served as framing members for the shelter, and details of the panel-joining geometry are shown in Figure 5. Additional panel constructional details are depicted in Figure 6. As seen in these

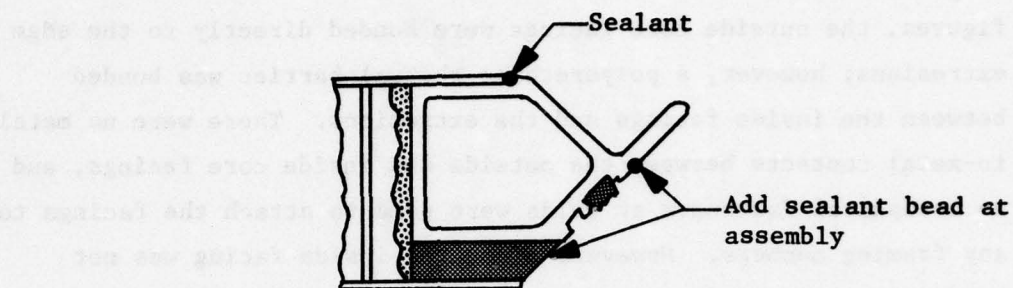
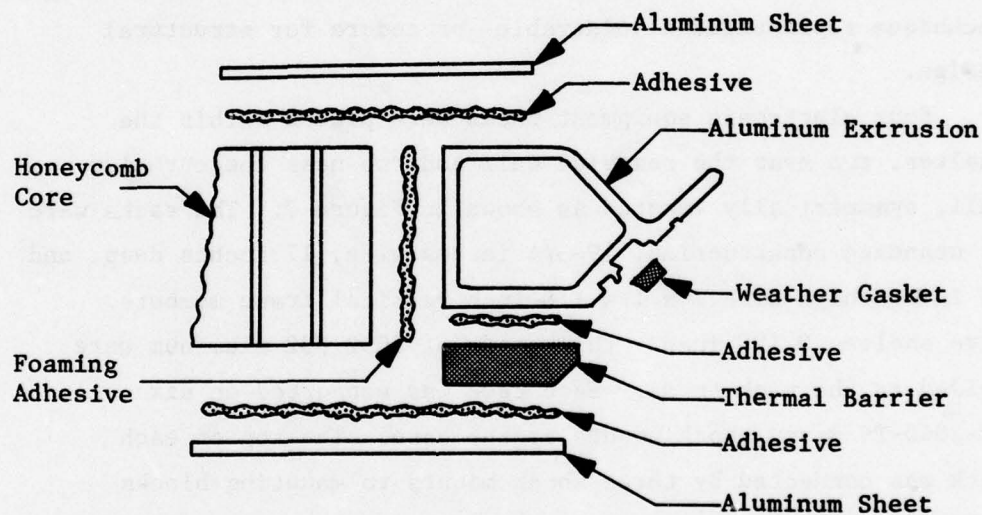
Panel Elements

- Protects and Seals Panel Edges
- Provides Self-Aligning Method of Joining Panels
- Retains Weather Gasket
- Provides for Modular Construction/Knock-Down Capability
- Isolates Metallic Components/No Through Metal

figures, the outside core facings were bonded directly to the edge extrusions; however, a polyurethane thermal barrier was bonded between the inside facings and the extrusions. There were no metal-to-metal contacts between the outside and inside core facings, and no mechanical fasteners or welds were used to attach the facings to any framing members. However, since the inside facing was not bonded directly to the edge extrusion (Figure 5 and 6), the transfer of local stresses to the edge extrusion relied on the integrity of the thermal barrier bond and the foaming adhesive. This joining technique represented a vulnerable procedure for structural design.

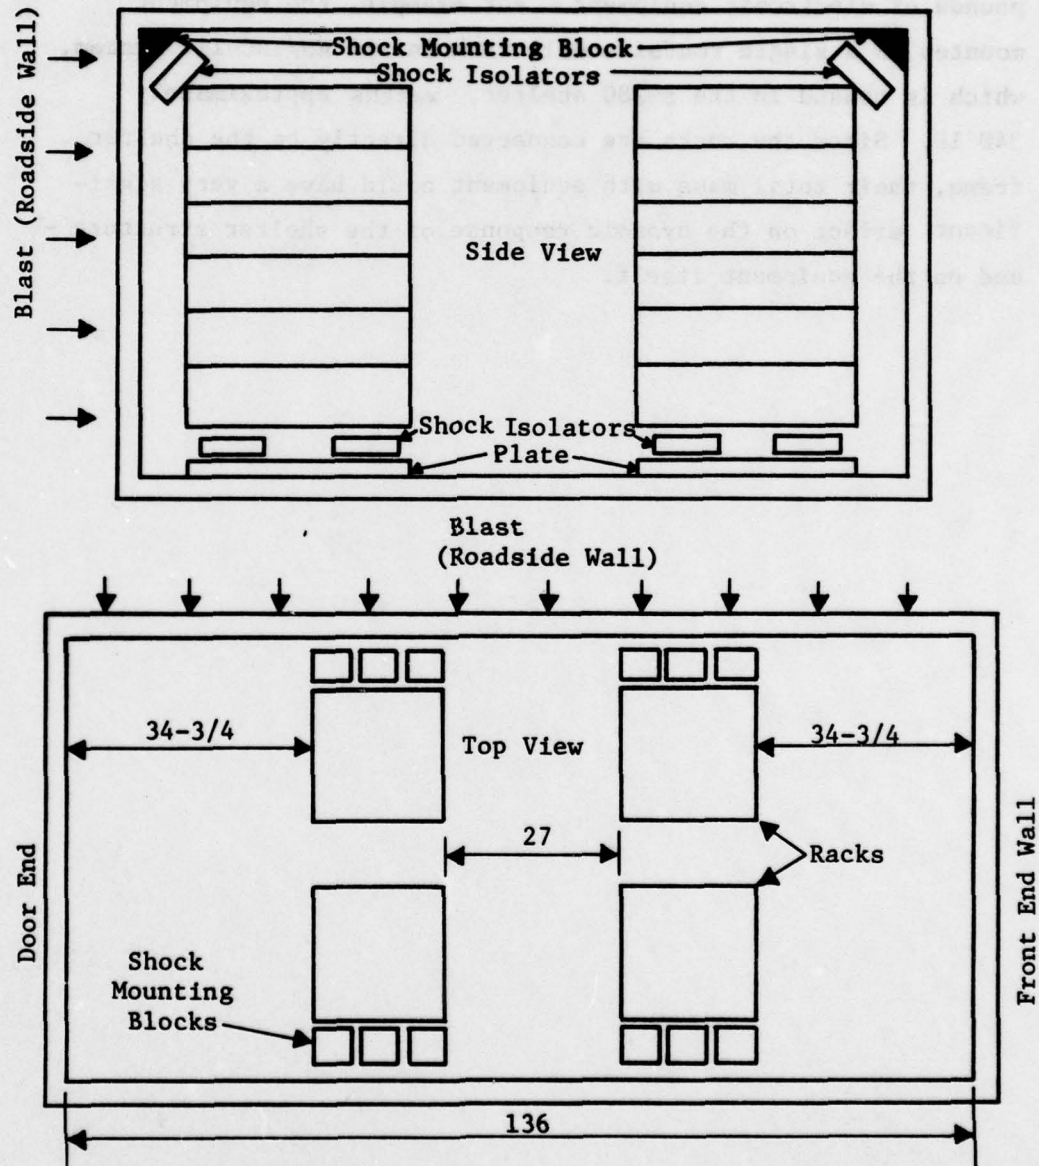
Racks - $19\frac{3}{4} \times 17 \times 69$ with $1 \times 1 \times \frac{1}{8}$ Al Tubing
 Rack Shelf (5) 5052 H32 Al 0.190 inch thick

Figure 7. Rack Installation

The weight of the empty MOD shelter was approximately 1928 lb, and the total weight with racks and shock mounting plates was 2300 lb; each rack frame weighed 55 lb. The racks did not support any electronic gear or simulated equipment weights during the test.

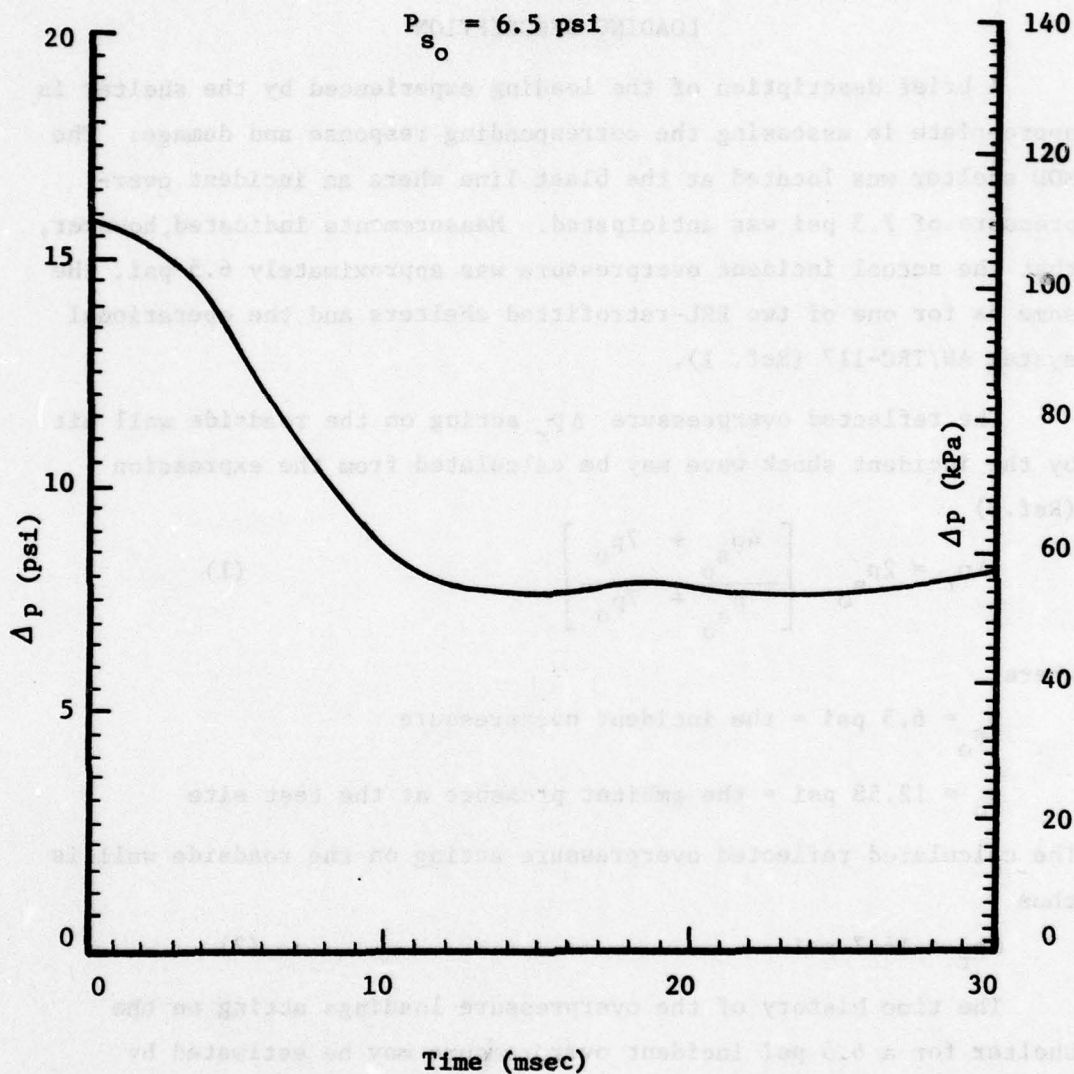
Figure 8. Estimated Overpressure Near Center of MOD Roadside Wall

milliseconds, diffractive effects have subsided at the roadside wall. The overpressure near the edges of the wall will be somewhat less because of the rarefaction waves. At the center of the roof, the calculated overpressure is given in Figure 9, reaching a peak of approximately 7.0 psi at about 5 milliseconds.

The shear forces on the roadside (blast side) wall would be greater than those on the roof because the applied overpressure is significantly greater (Fig. 8 compared to Fig. 9). Therefore the roadside wall would also be expected to fail in shear. With regard to the bending stresses in the roadside wall, it was seen that considerable core shear failure occurred at the vertical stiffening extrusion. Therefore the stiffener at some point in time became ineffective in resisting the bending stresses because of failure in the shear transfer mechanism. Assuming the stiffener to be completely ineffective in reducing the panel bending stresses, the maximum panel bending stresses calculated by the above procedure would be 65,000 psi for the roadside wall. The stiffener obviously provided some bending resistance for the panel, but not to the extent

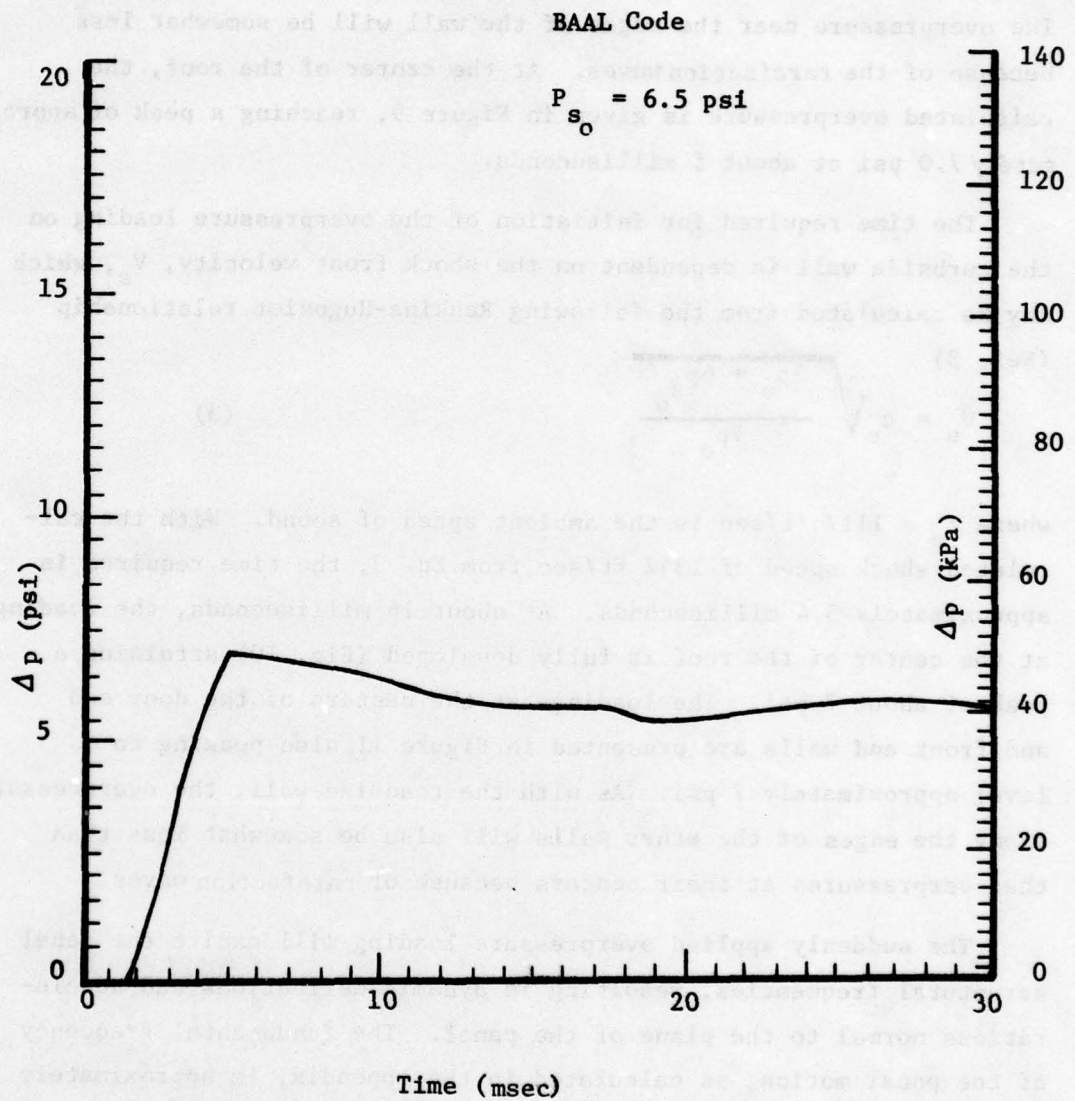
Figure 9. Estimated Overpressure Near Center of MOD Roof

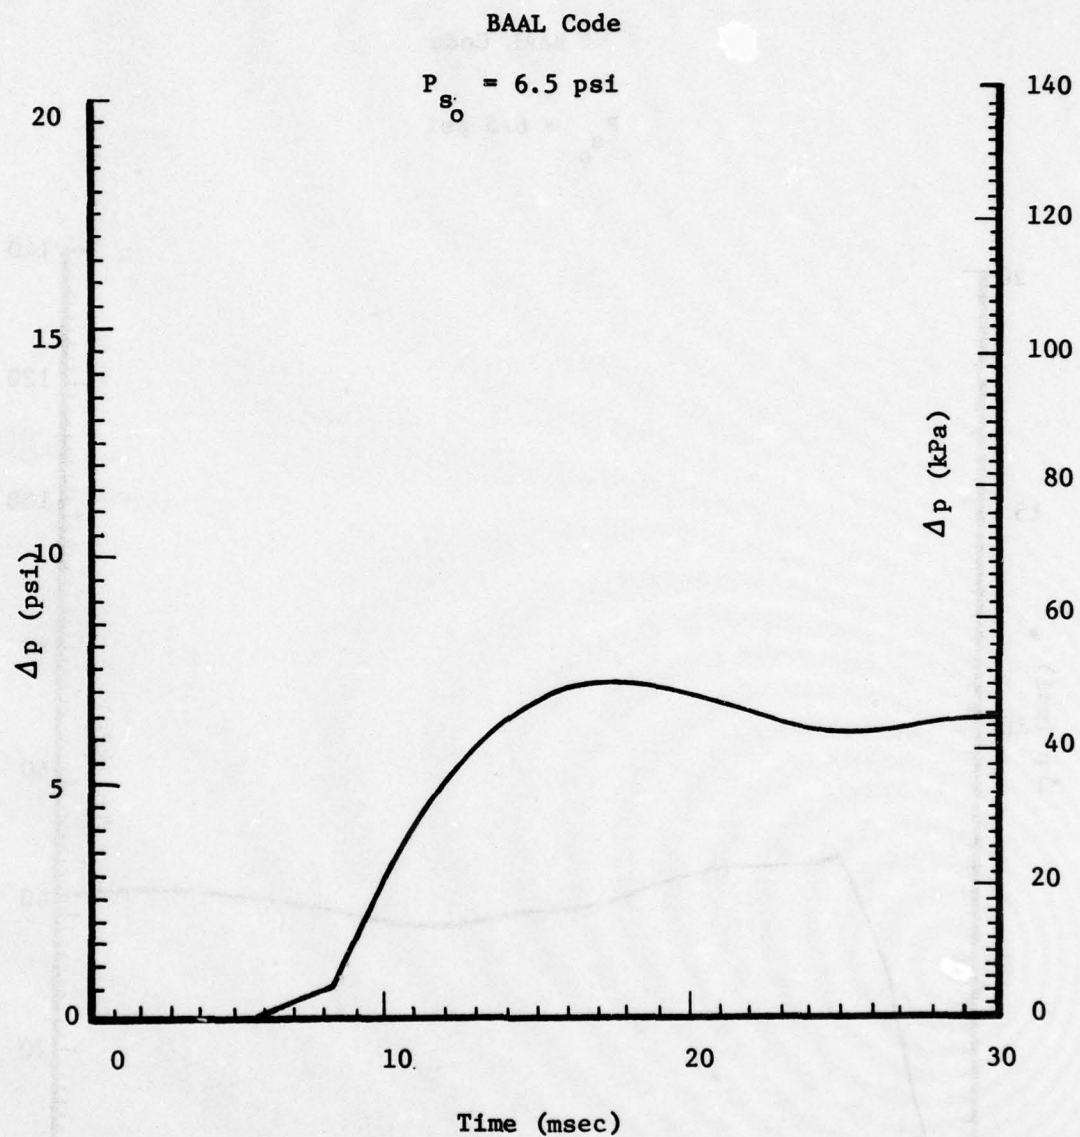
Figure 10. Overpressure Near Center of MOD Curbside Wall

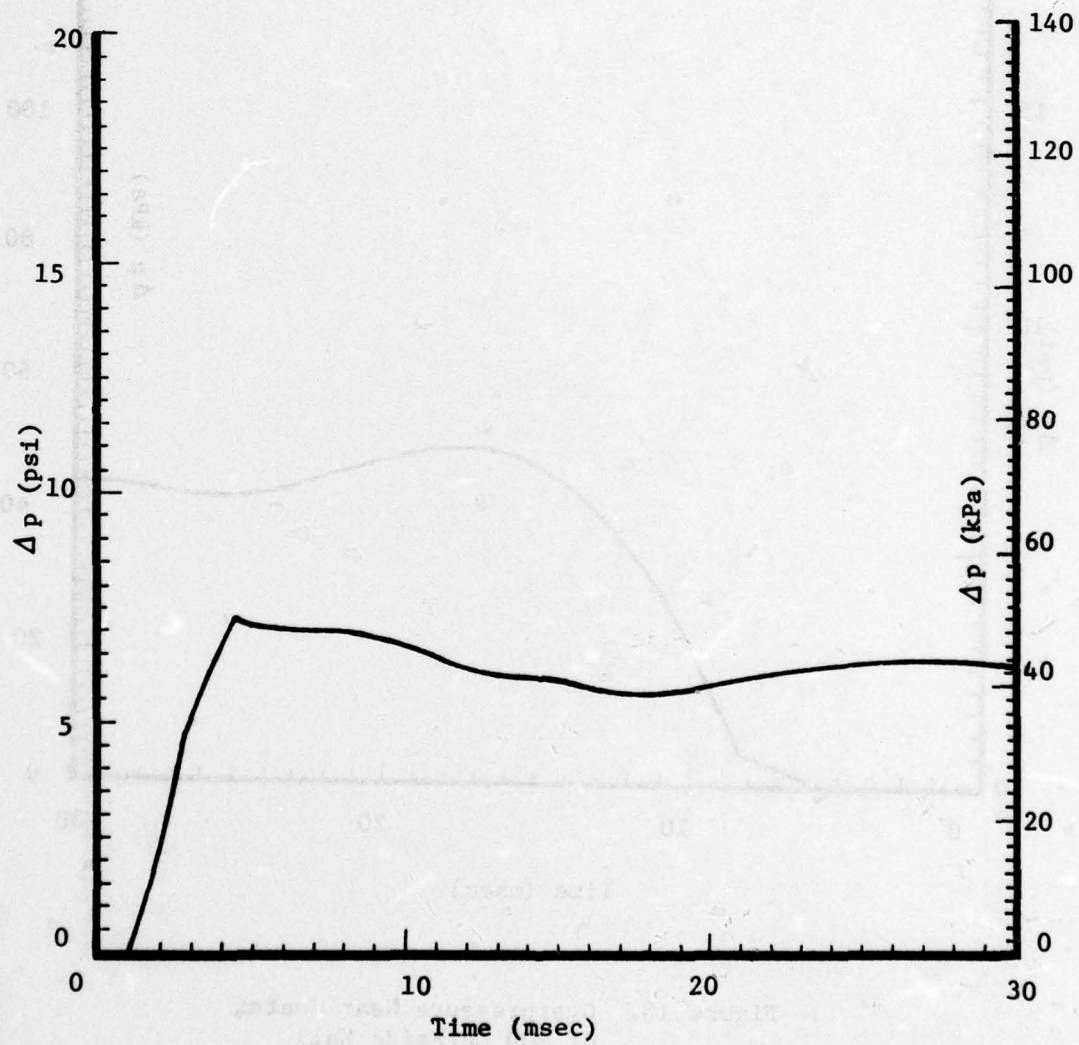
Figure 11. Estimated Overpressure Near Center of MOD Front End and Door End Wall

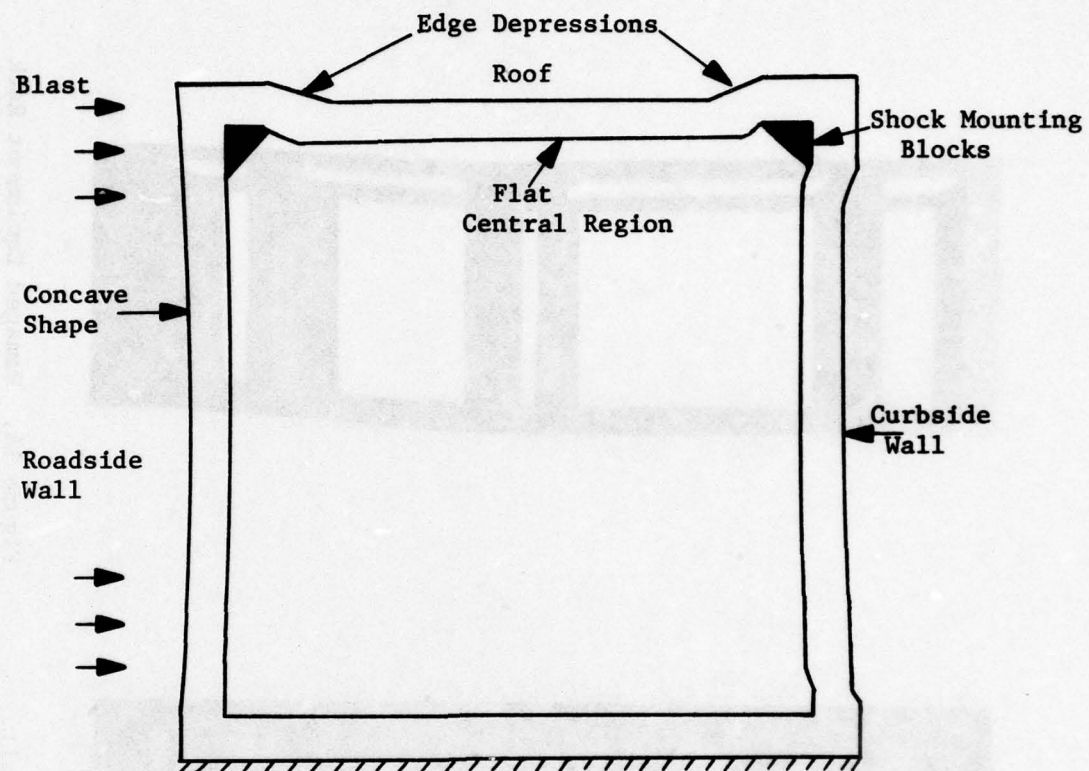
Figure 12. Cross-Section View of Shelter Wall Deformations at Mid-Section

The roof and curbside walls did not display the concave-like deformation pattern of the roadside wall. Instead, these surfaces exhibited large depressions near the wall edges with a large flat-shaped region between edges. The deformation in the roof began along the edges of the isolator mounting blocks that were bolted to the lengthwise edge extrusions of the roof. The depression along the edge and the flatness of the central portion of the roof are shown in Figure 15. Had the upper mounting blocks not been present,

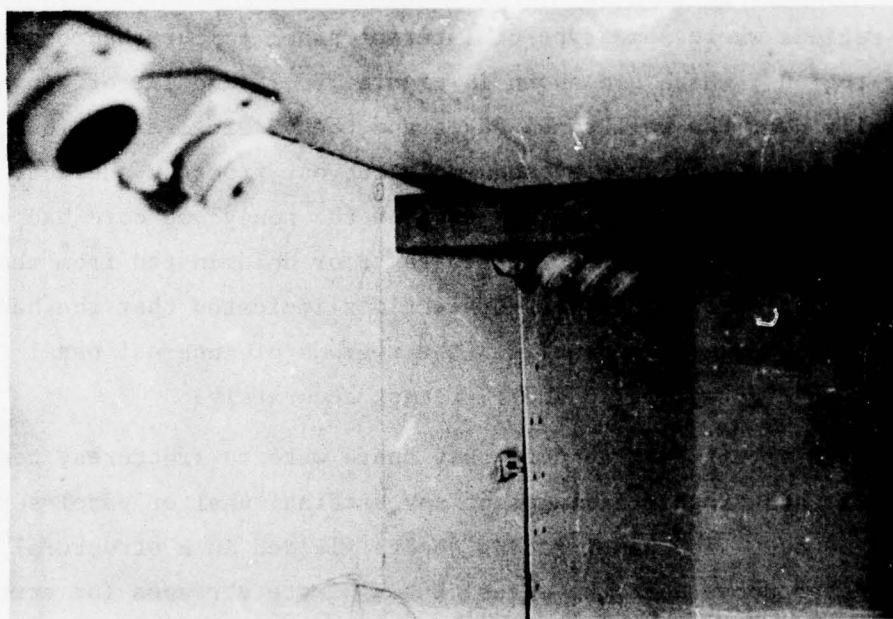
Figure 15. Depression of Roof, Straight Edge Indicating Flatness of Central Region

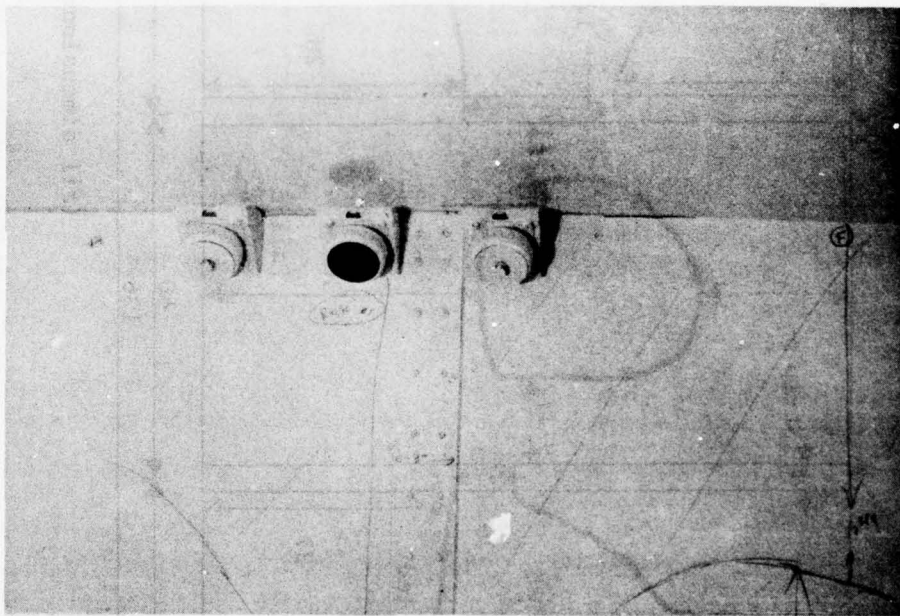
deformation most likely would have occurred closer to the roof edge extrusions. The condition of the roof and roadside wall near the mounting blocks is shown in Figure 16.

Figure 16. Condition of Intersection of Roof and Roadside Wall. Upper Shock Mounting Blocks and Wall Splice

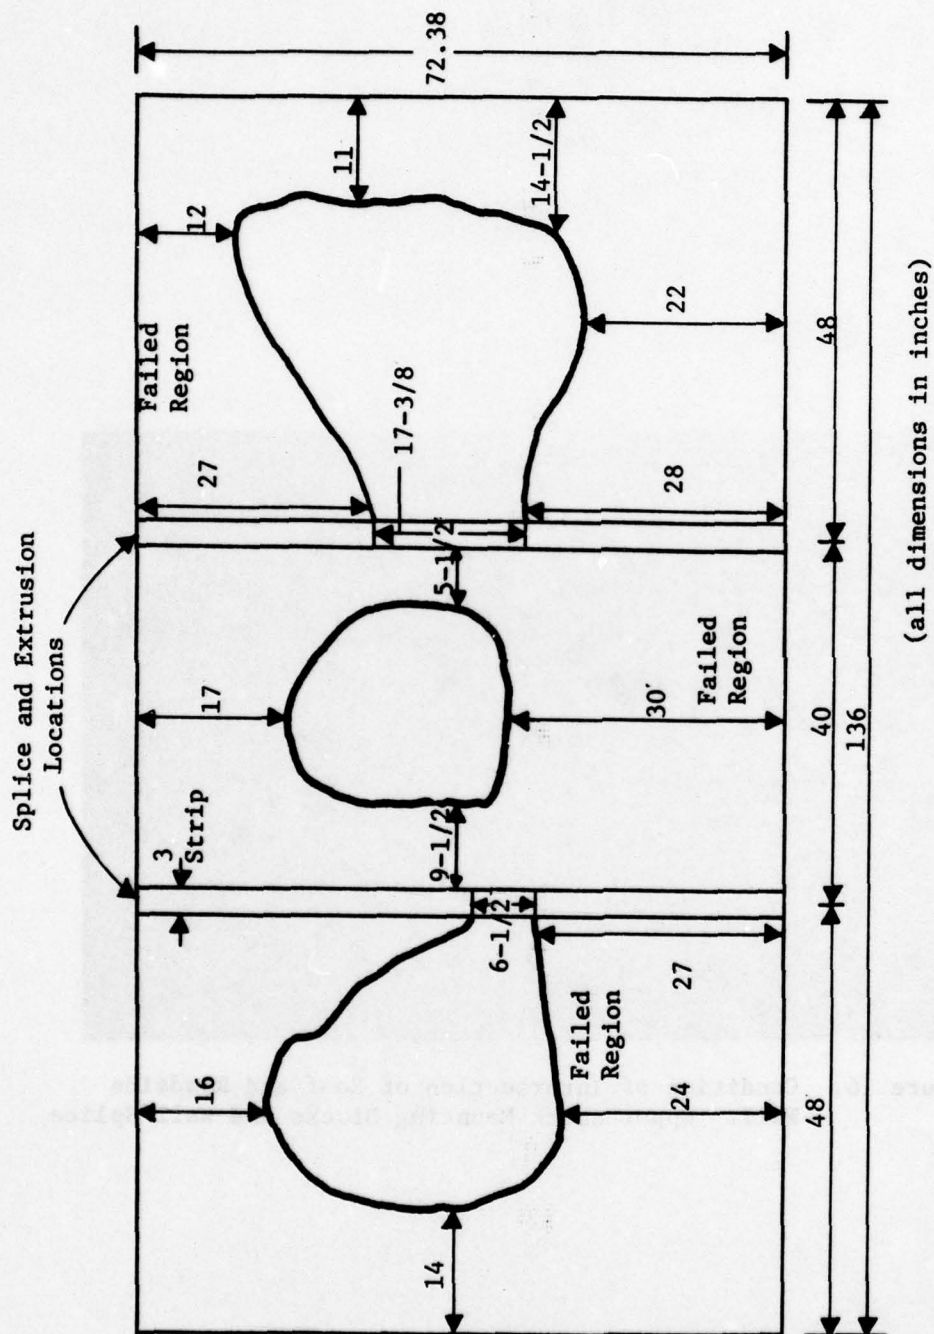
Careful tapping of the wall surfaces with a light hammer identified regions where some type of internal panel failure had occurred. These regions, which are shown in Figures 17, 18 and 19, originated typically near the wall panel edges and the vertical extrusions. When panel sections were subsequently cut out from the shelter, it was seen that in these "failed" regions the honeycomb core had either ruptured in shear or otherwise separated or delaminated from the panel facing sheets. The cut-up sections indicated that the hammer-tapping technique had identified the regions of internal panel failure in Figures 17, 18 and 19 rather accurately.

Figure 17. Internal Failure Regions - Roadside Wall

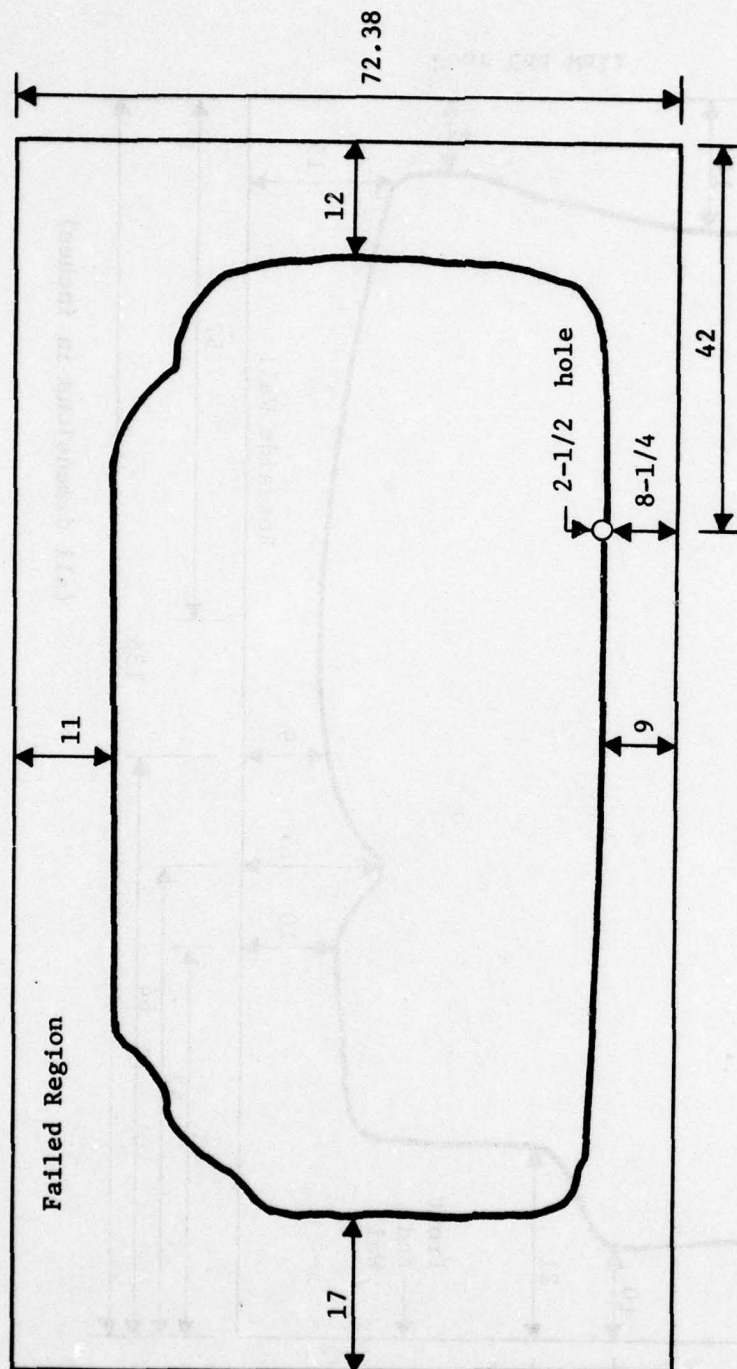
Figure 19. Internal Failure Regions - Curbside Wall

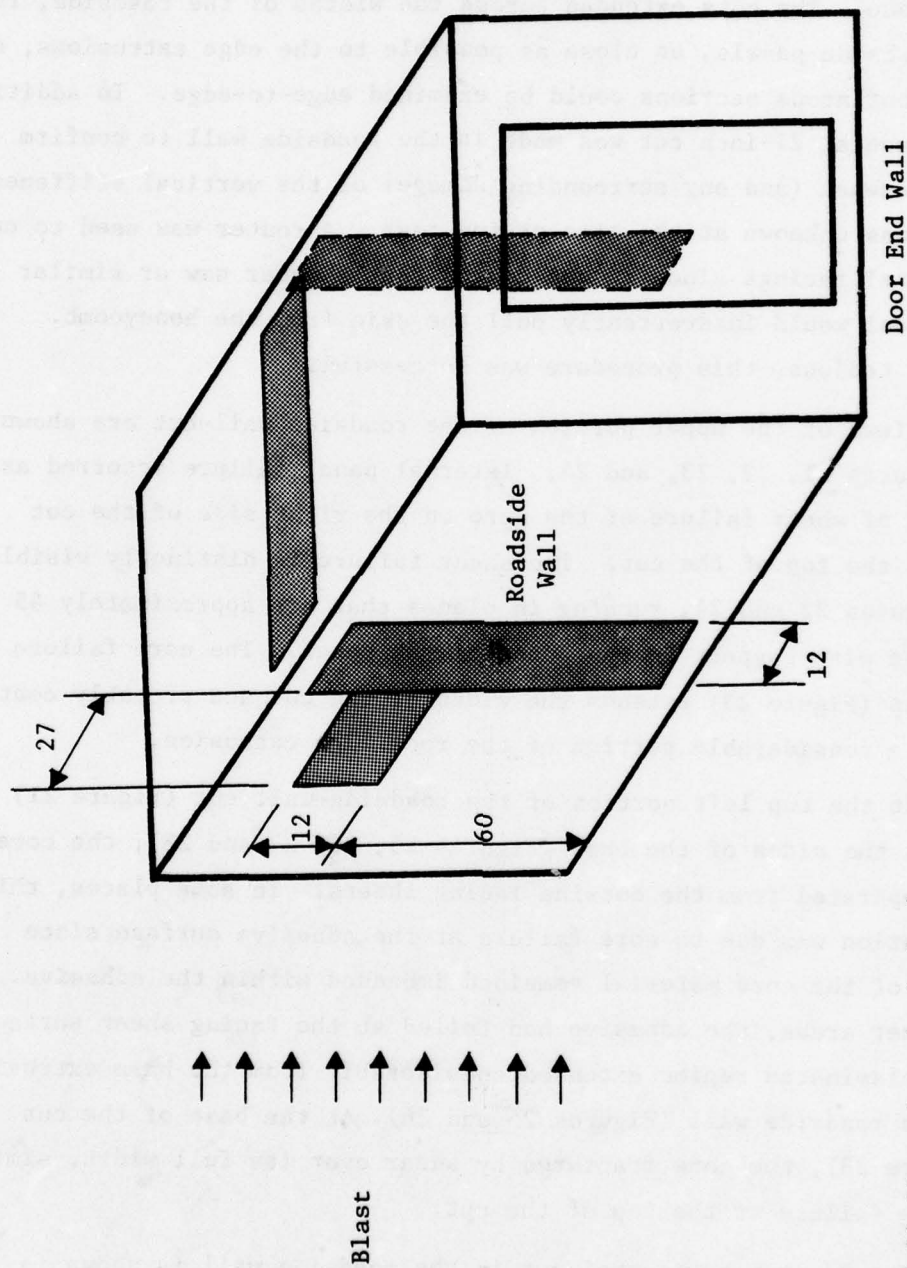
deformations were the greatest there. Figure 20 illustrates the cuts made. The cuts extended across the widths of the roadside, roof, and curbside panels, as close as possible to the edge extrusions, so that continuous sections could be examined edge-to-edge. In addition, a horizontal 27-inch cut was made in the roadside wall to confirm the presence (and any surrounding damage) of the vertical stiffener, which was unknown at the time of the test. A router was used to cut the metal facings since it was feared that a saber saw or similar such tool would inadvertently pull the skin from the honeycomb. Though tedious, this procedure was successful.

Figure 20. Sections Cut Out from Brunswick MOD Shelter

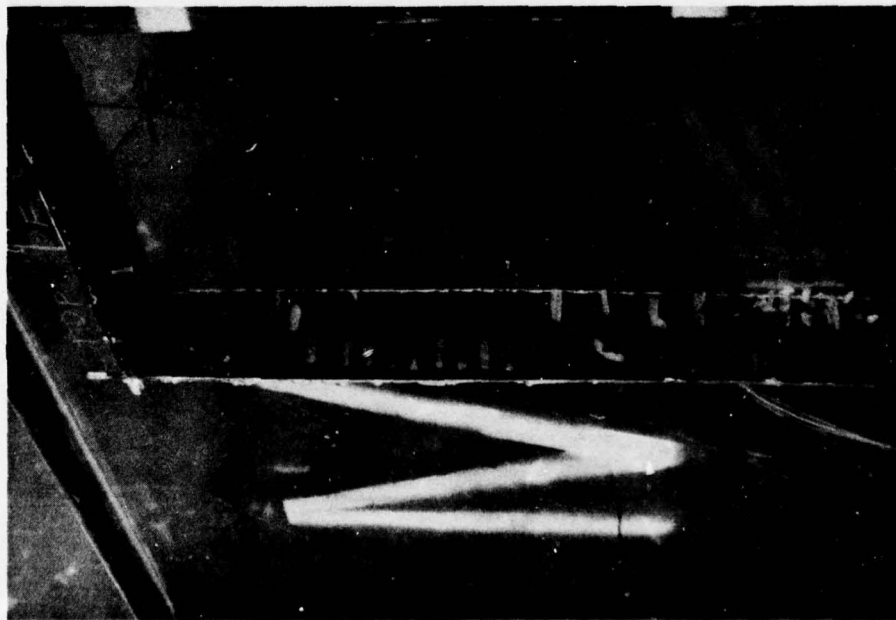
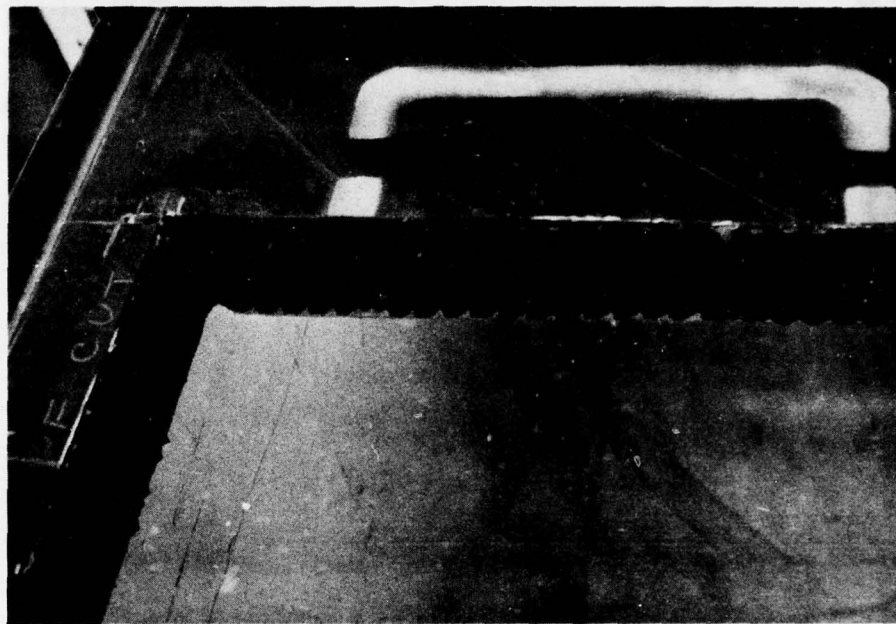
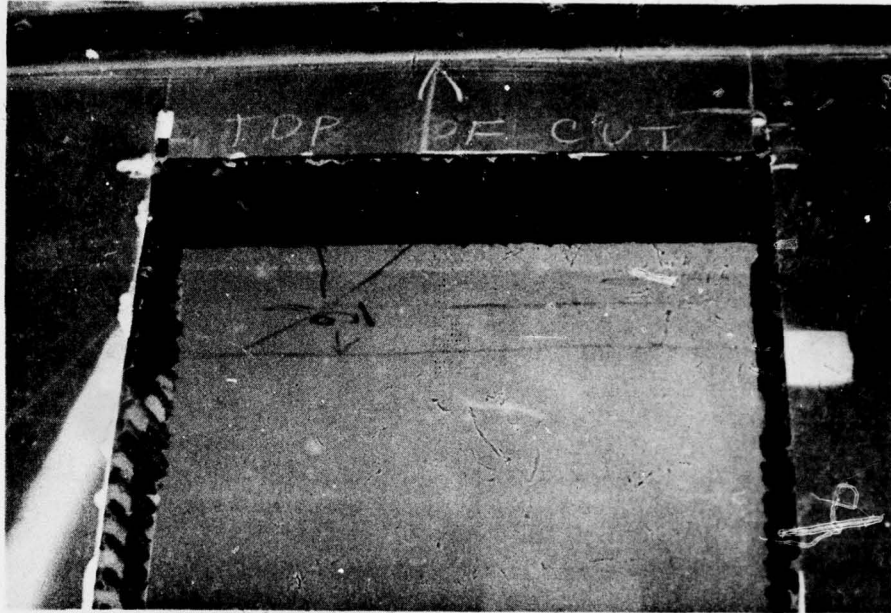
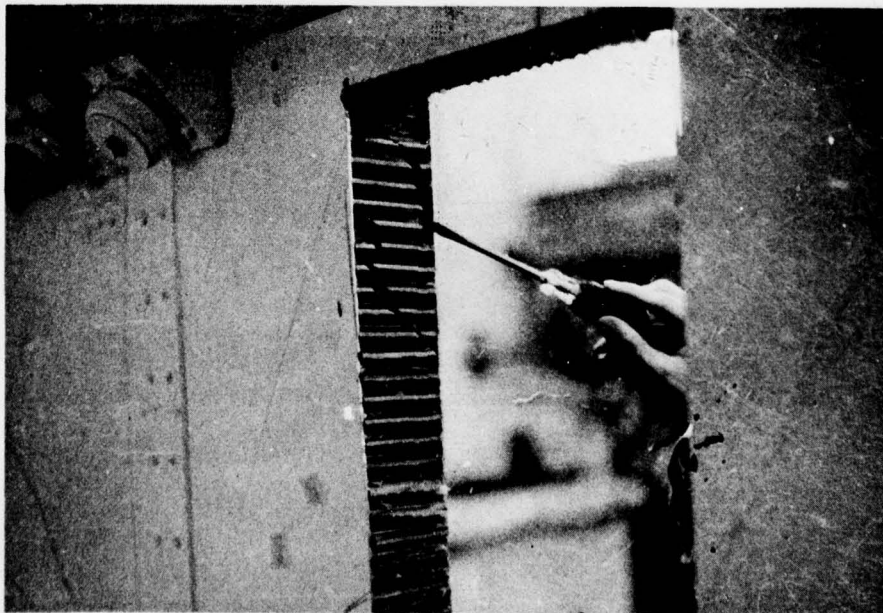
Views of the upper portion of the roadside wall-cut are shown in Figures 21, 22, 23, and 24. Internal panel failure occurred as a result of shear failure of the core on the right side of the cut and at the top of the cut. The shear failure is distinctly visible in Figures 22 and 24, running in planes that are approximately 45 degrees with respect to the plane of the panel. The core failure at the top (Figure 23) extends the width of the cut and probably continues along a considerable portion of the roof edge extrusion.

Figure 21. Roadside Wall Cut, Exterior
View Toward Front End Wall

Figure 22. Roadside Wall Cut, Exterior
View Toward Door End Wall

Figure 23. Roadside Wall Cut, Exterior View

Figure 24. Roadside Wall Cut, Interior View Toward Door End Wall

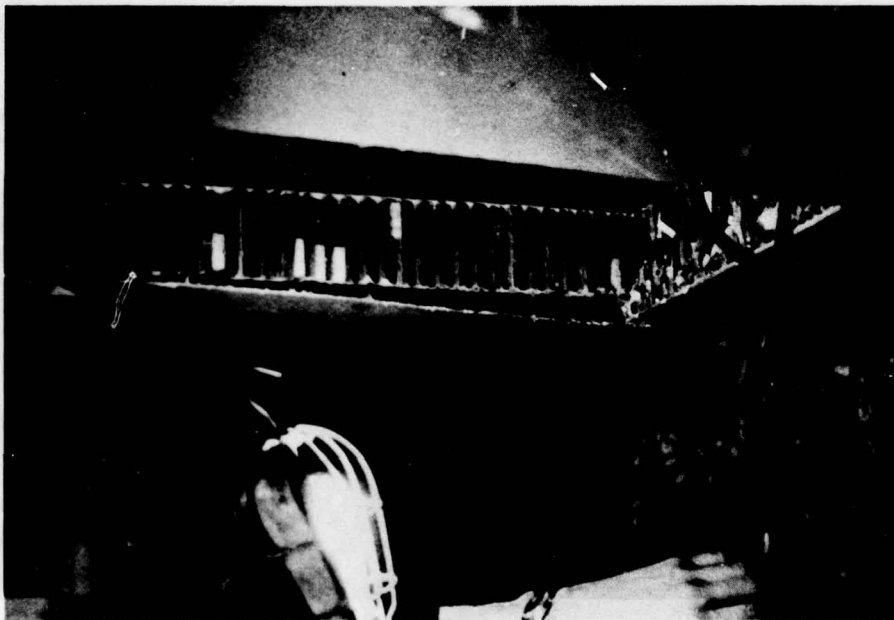
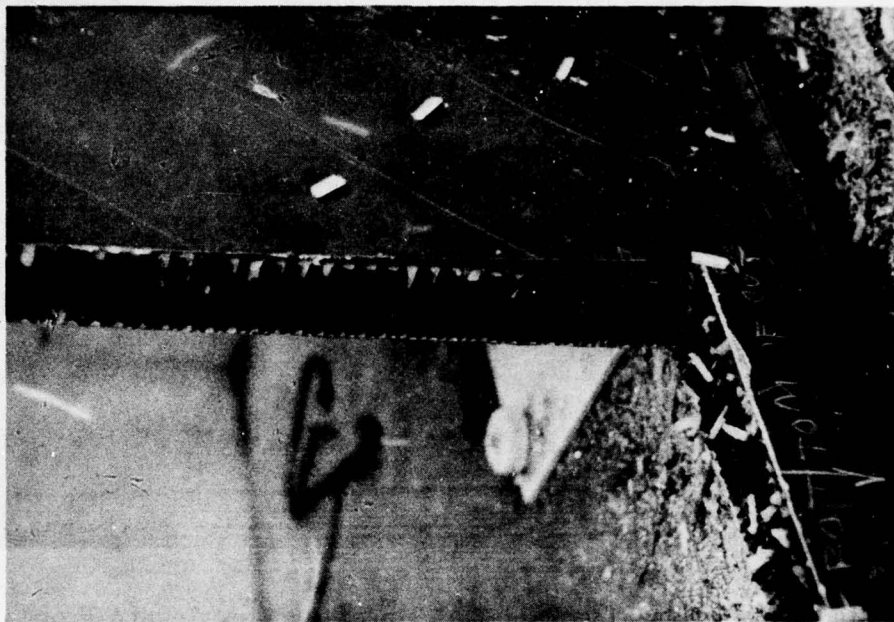
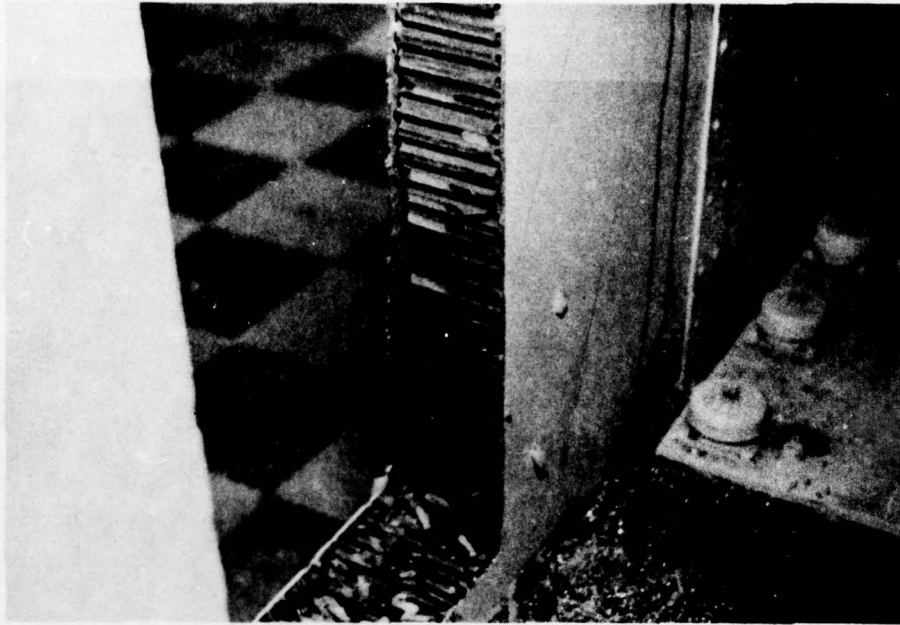
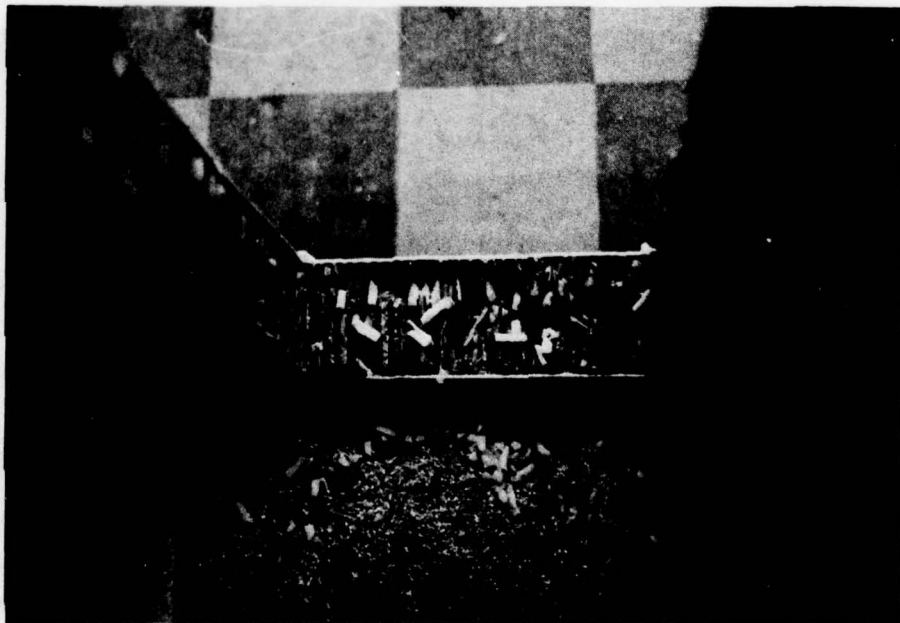
At the top left portion of the roadside-wall cut (Figure 21) and at the sides of the base (Figures 25, 26, 27 and 28), the core had separated from the outside facing sheets. In some places, this separation was due to core failure at the adhesive surface since parts of the core material remained imbedded within the adhesive. In other areas, the adhesive had failed at the facing sheet surface. The delaminated region extended considerably from the base extrusion on the roadside wall (Figures 25 and 26). At the base of the cut (Figure 28), the core fractured by shear over its full width, similar to the failure at the top of the cut.

Figure 25. Roadside Wall Cut, Exterior
View Toward Front

Figure 26. Roadside Wall Cut, Exterior
View Toward Door

Figure 27. Roadside Wall Cut, Interior View Toward Front End Wall. Equipment Rack Shock Isolators

Figure 28. Roadside Wall Cut, Interior View of Base
